# **SOURCE AREA CHARACTERIZATION - UBZ-2**

# **Monsanto Soda Springs Idaho Plant**

Submitted By: Golder Associates Inc.

October 2012

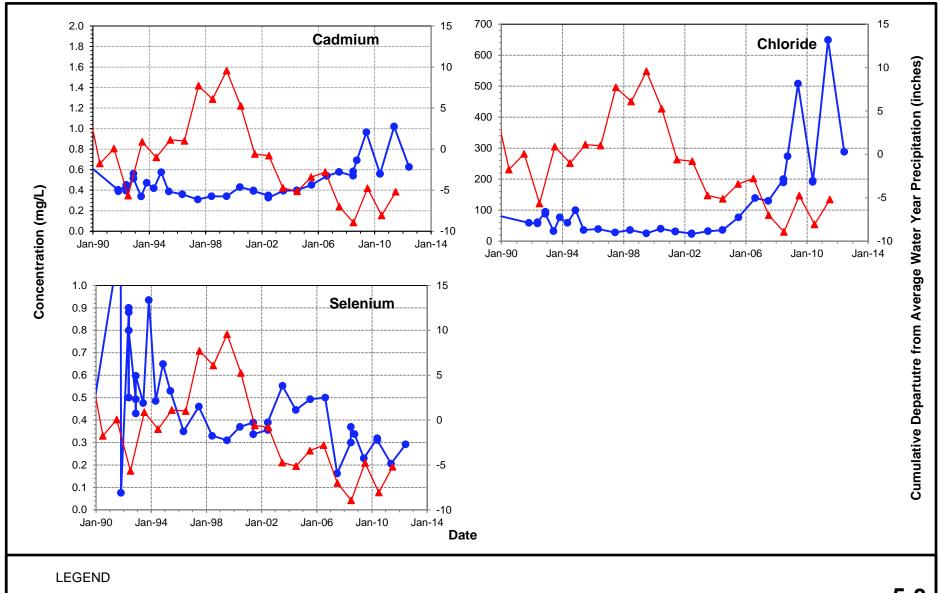
FIGURE **5-3**

**TW-37 Constituent Concentrations and Departure from Average Water Year Precipitation** → Departure from Average Water Year Precipitation since 1990

Infiltration of precipitation through the materials capping the Old UFS ponds (crushed slag, bentonite cap, and molten slag fill) could mobilize constituents from remnant underflow solids in the Old UFS ponds. Infiltration of precipitation in areas around the Old UFS Ponds footprint could result in dissolution of secondary minerals in the vadose zone. Figure 5-1 and 5-2 show the relationship between water year precipitation and concentrations of cadmium, chloride, and selenium in TW-37 and TW-22 and TW-24, respectively. Figures 5-3 and 5-4 show the concentrations of the same constituents in TW-37 and TW-22 and TW-24, respectively, and the cumulative departure from average water year precipitation.

■ In TW-37, there does not seem to be a relationship between precipitation and cadmium concentration until about 2009. Between about 1994 and 2004 cadmium concentrations are relatively stable, while the cumulative departure from average water year precipitation increases through 1999, then generally decreases through 2008. In 2009 and 2011, cadmium concentrations show a short-term increase coincident with increased precipitation, while in 2009 and 2012, cadmium concentrations show a sharp decrease, coincident with decreased precipitation (Figure 5-1). Chloride concentrations show similar trends. The observed increase in cadmium concentrations is likely related to the coincident increase in chloride concentrations. Infiltration of precipitation likely mobilizes remnant magnesium chloride dust suppressant materials in the soils around the Old UFS Ponds, resulting in increased chloride concentrations in the infiltrating water and

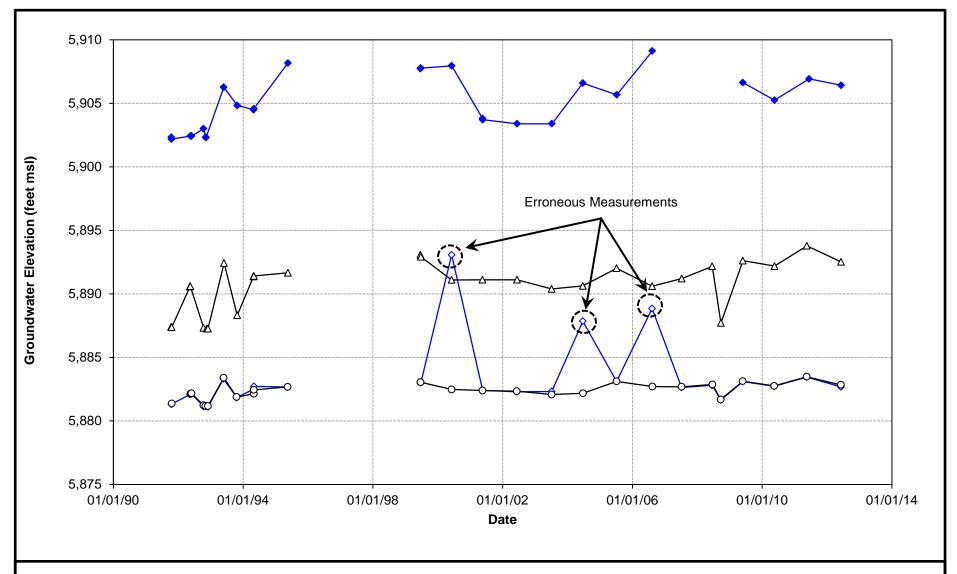
—
→ TW-37 (UBZ-2) → TW-26 (UBZ-4)

**GROUNDWATER ELEVATIONS IN UBZ-2 SOURCE AREA WELLS AND TW-26**

The highest groundwater elevation in TW-37 was 5,893.78 feet msl in May 2011. The floor elevation of the Old UFS Ponds when they were in operation is not known. Review of the 1970 topographic map indicates the southern pond was excavated to an elevation of at least 5,936 feet msl (Figure 3-2). This is about 42 feet above the highest observed groundwater elevation (May 2011). Therefore, it is unlikely that the groundwater elevation reached the base of the ponds while the ponds were in operation or since closure.

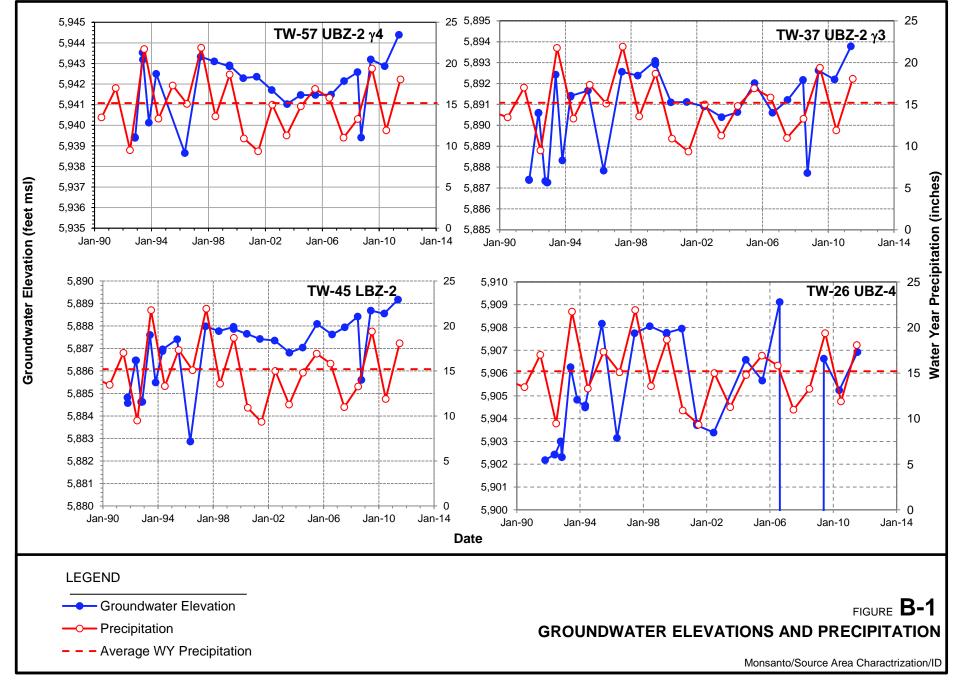
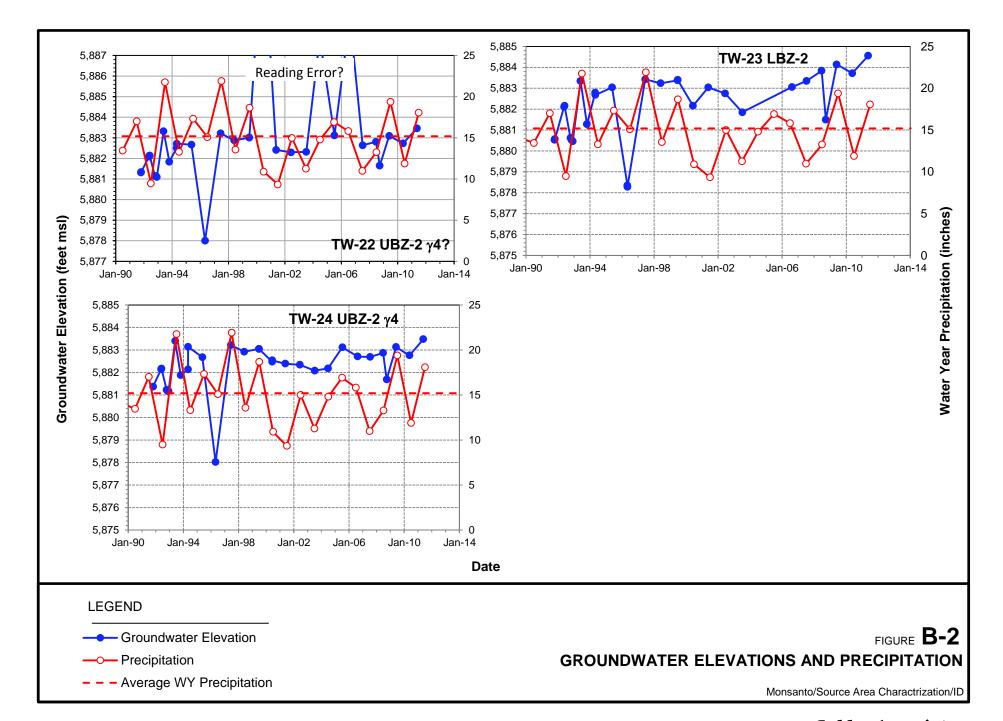
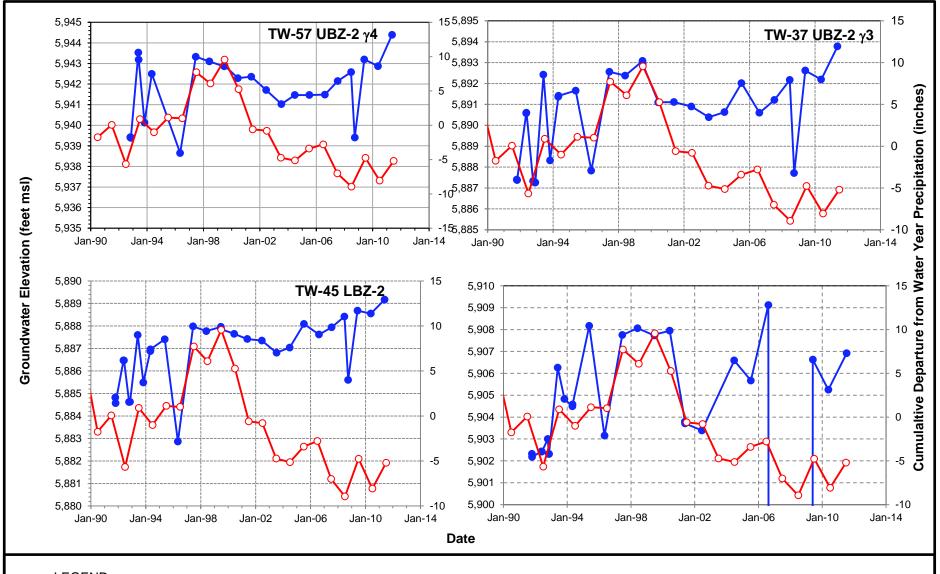
GROUNDWATER ELEVATIONS AND DEPARTURE FROM AVERAGE WATER YEAR PRECIPITATION
